**Flood Control Project Maintenance
Levee Inspections
LMA District Cover Sheet
Spring 2010 Levee Inspection Results**

San Joaquin County Flood Control and Water Conservation District

Spring 2010 Levee Inspection Results

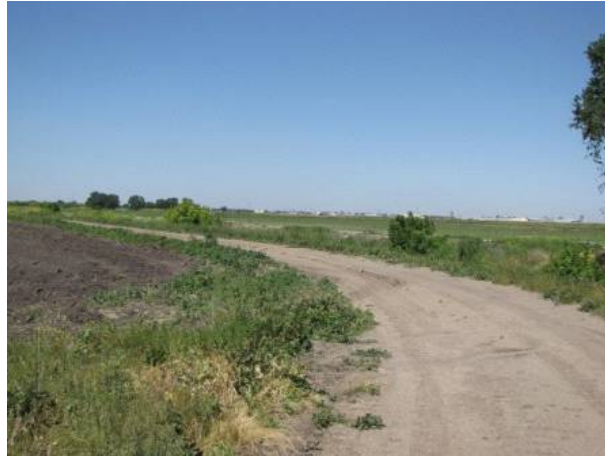
View of vegetation on the landward shoulder looking downstream.

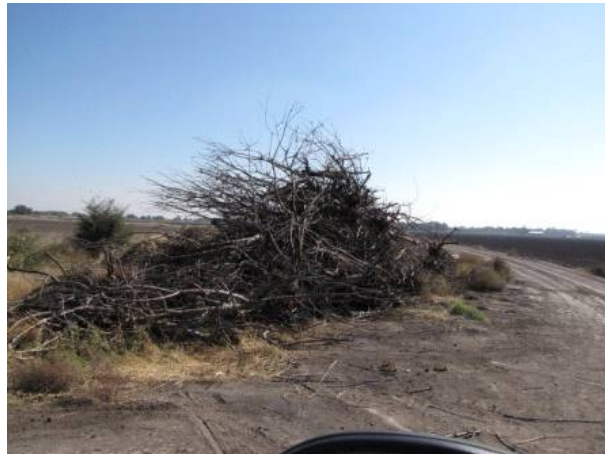
Levee Mile Report Line	3
Start Levee Mile	0.42
End Levee Mile	0.42
Location	Water Side
Category	Earthen Levee
Item	Encroachments

View of a prunings pile on the waterward side of the levee looking upstream.

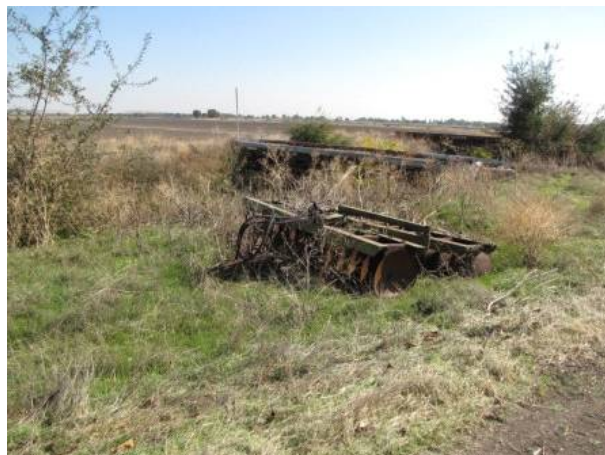
Levee Mile Report Line	4
Start Levee Mile	0.45
End Levee Mile	0.45
Location	Water Side
Category	Earthen Levee
Item	Encroachments

View of equipment on the waterward side of the levee looking upstream.

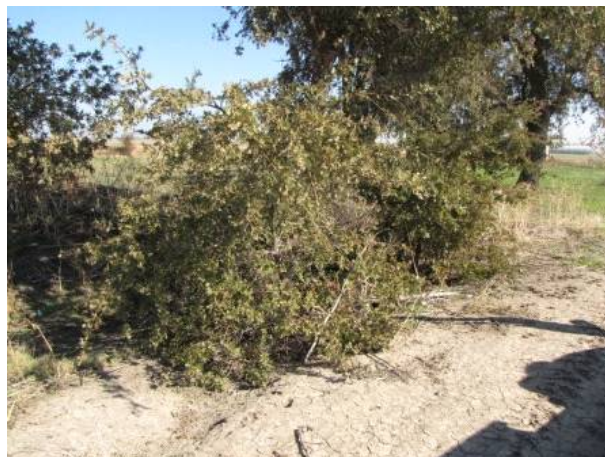
View of tree branches blocking visibility and access on the waterward side of the levee looking upstream.

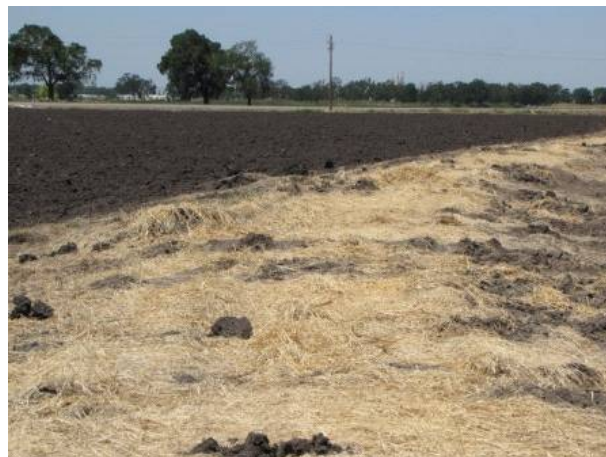
View of damage to the crown of the levee caused by the landowner driving a tractor over the levee looking downstream.

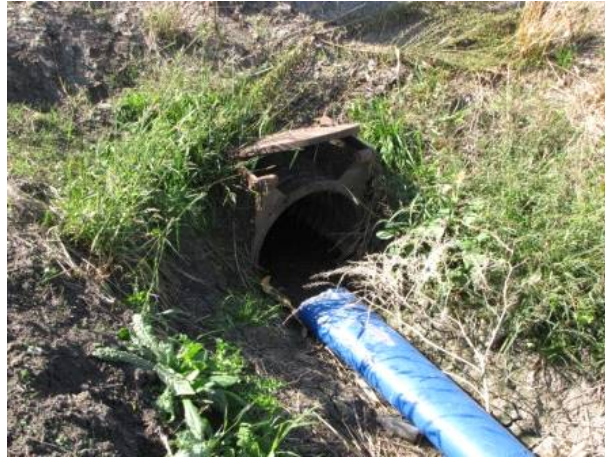
View of a blocked flap gate on the waterward side of the levee. Debris and sediment prevent this gate from closing.

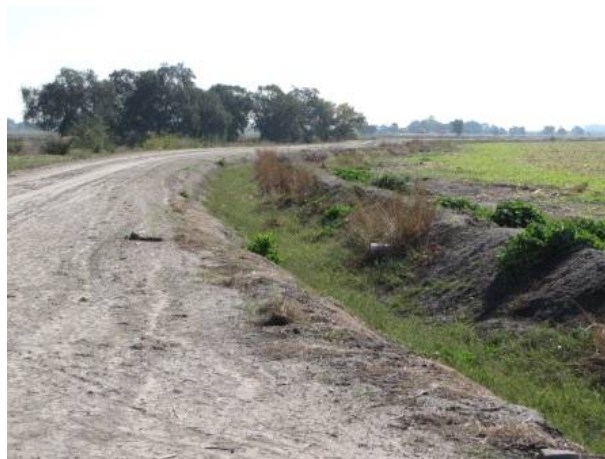
Levee Mile Report Line	20
Start Levee Mile	1.60
End Levee Mile	2.25
Location	Land Side
Category	Earthen Levee
Item	Encroachments

View of an agricultural ditch on the landward side of the levee looking upstream.

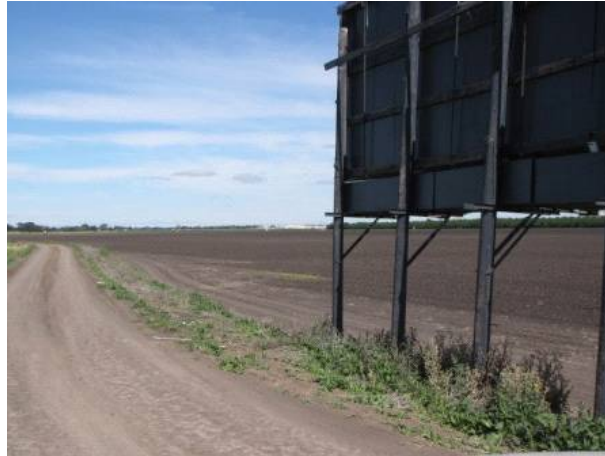
View of vegetation on the landward slope looking downstream.

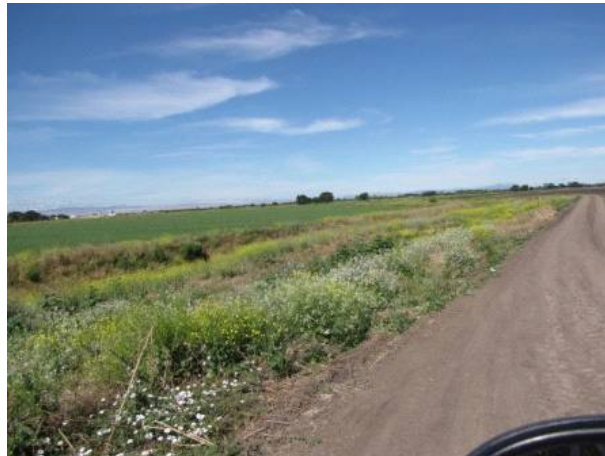
Levee Mile Report Line	2
Start Levee Mile	0.00
End Levee Mile	1.27
Location	Water Side
Category	Earthen Levee
Item	Vegetation

View of vegetation on the waterward slope looking downstream.

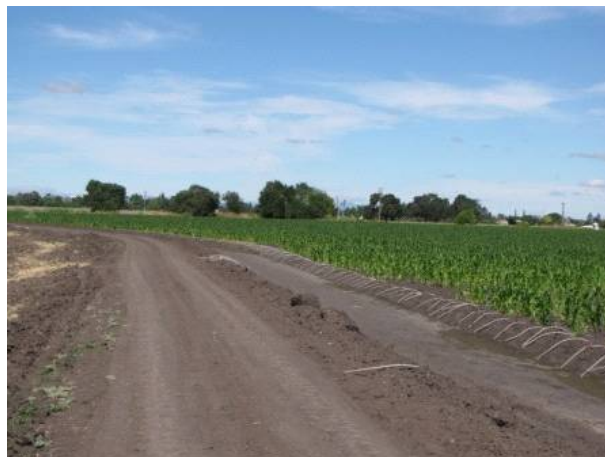
Levee Mile Report Line	8
Start Levee Mile	1.51
End Levee Mile	1.87
Location	Land Side
Category	Earthen Levee
Item	Encroachments

View of an agricultural ditch on the landward side looking downstream.

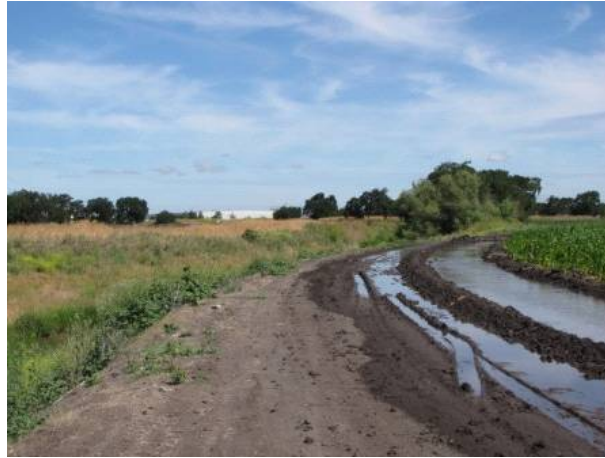
View of vegetation on the waterward slope and the un-passable saturated crown looking downstream

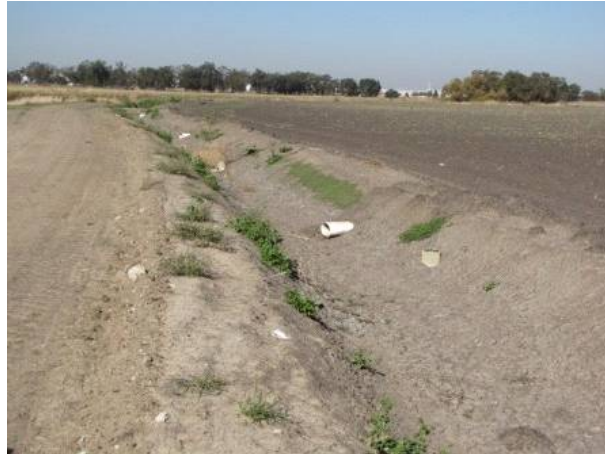
Levee Mile Report Line	10
Start Levee Mile	1.92
End Levee Mile	2.21
Location	Land Side
Category	Earthen Levee
Item	Encroachments

View of an agricultural ditch on the landward side of the levee looking downstream.

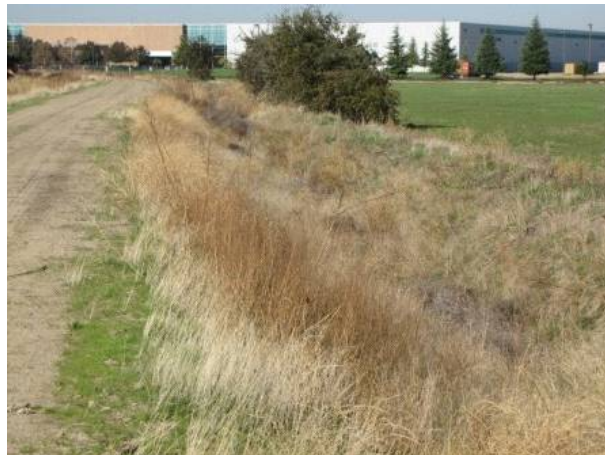
Levee Mile Report Line	13
Start Levee Mile	2.66
End Levee Mile	3.17
Location	Land Side
Category	Earthen Levee
Item	Encroachments

View of an agricultural ditch on the landward side of the levee looking downstream.

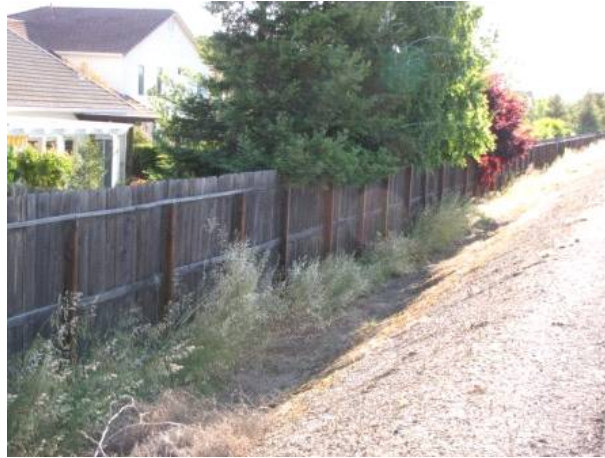
View of vegetation at the landward toe looking upstream.

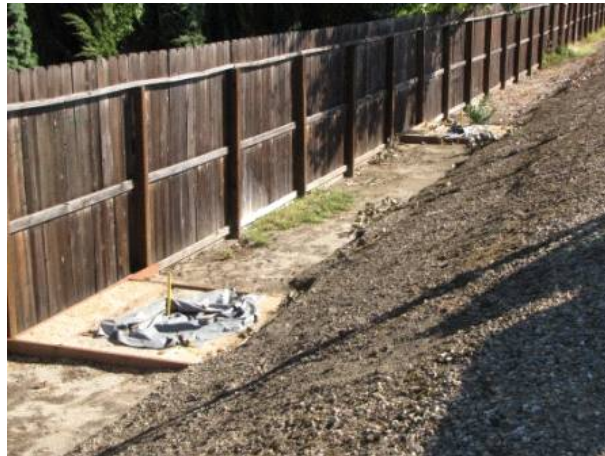
Levee Mile Report Line	4
Start Levee Mile	0.76
End Levee Mile	0.76
Location	Land Side
Category	Earthen Levee
Item	Encroachments

View of unauthorized horseshoe pits along the landward toe looking upstream.

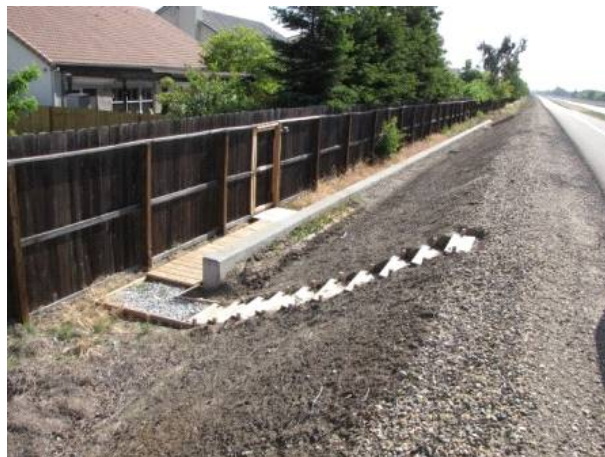
Levee Mile Report Line	5
Start Levee Mile	0.81
End Levee Mile	0.81
Location	Land Side
Category	Earthen Levee
Item	Encroachments

Stairs dug into levee slope. Remove the steps and recompact the levee slope.

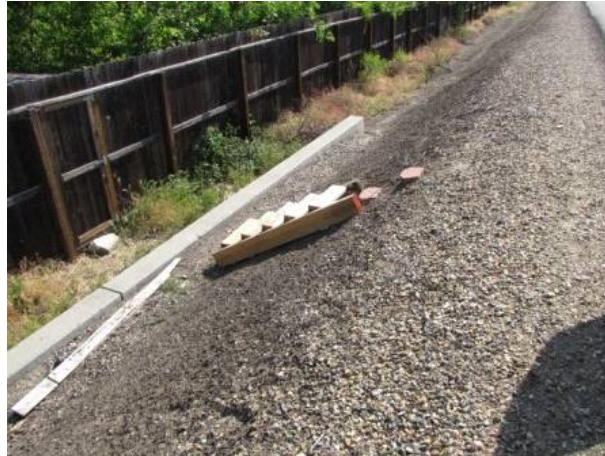
Stairs on landward slope of levee.

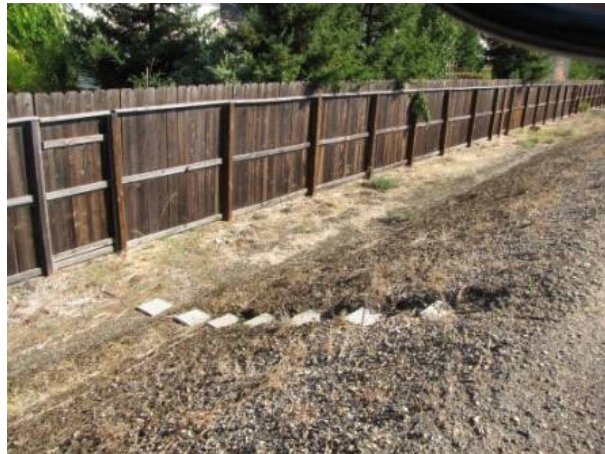
Levee Mile Report Line	7
Start Levee Mile	0.94
End Levee Mile	0.94
Location	Land Side
Category	Earthen Levee
Item	Encroachments

View of unauthorized steps dug into the landward slope looking upstream.

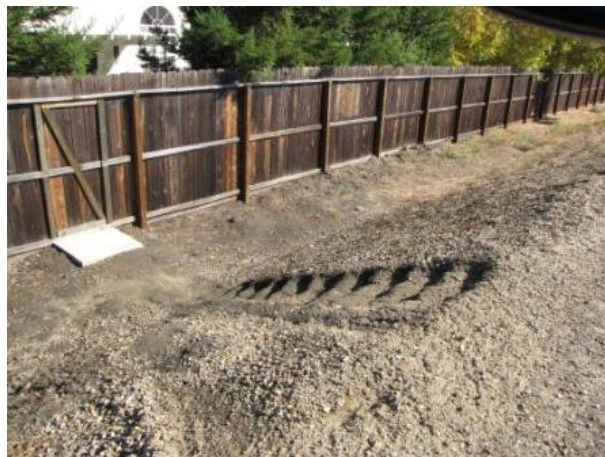
Levee Mile Report Line	8
Start Levee Mile	0.97
End Levee Mile	0.97
Location	Land Side
Category	Earthen Levee
Item	Encroachments

View of unauthorized steps dug into the landward slope looking upstream.

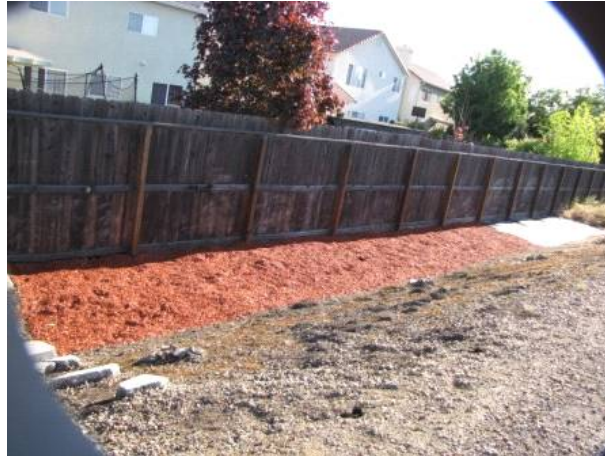
View of landscaping mulch and fabric placed at the landward toe.

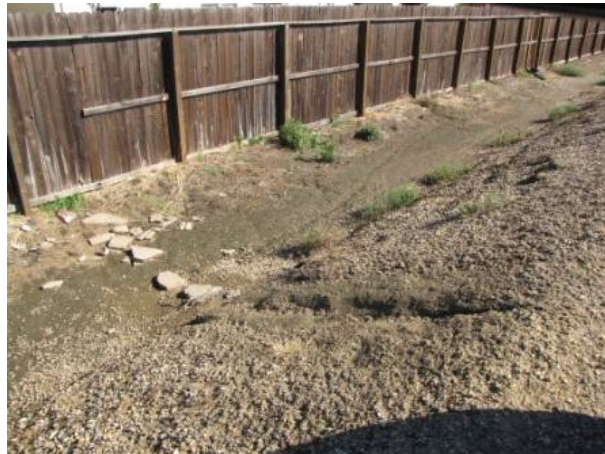
Levee Mile Report Line	10
Start Levee Mile	1.11
End Levee Mile	1.11
Location	Land Side
Category	Earthen Levee
Item	Encroachments

View of unauthorized steps dug into the landward slope looking upstream.

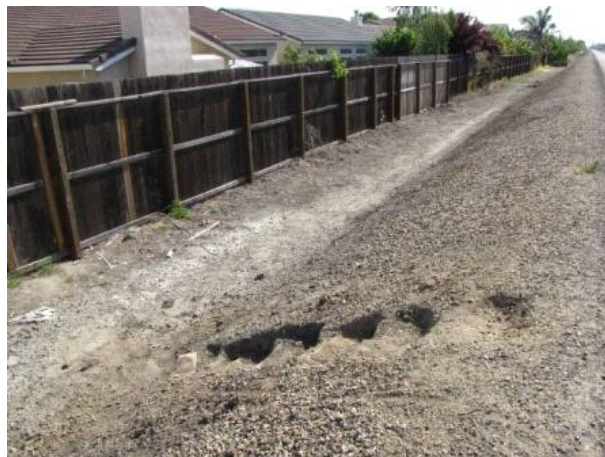
Levee Mile Report Line	11
Start Levee Mile	1.13
End Levee Mile	1.13
Location	Land Side
Category	Earthen Levee
Item	Encroachments

Steps dug into landward slope of levee. Backfill and recompact the slope.

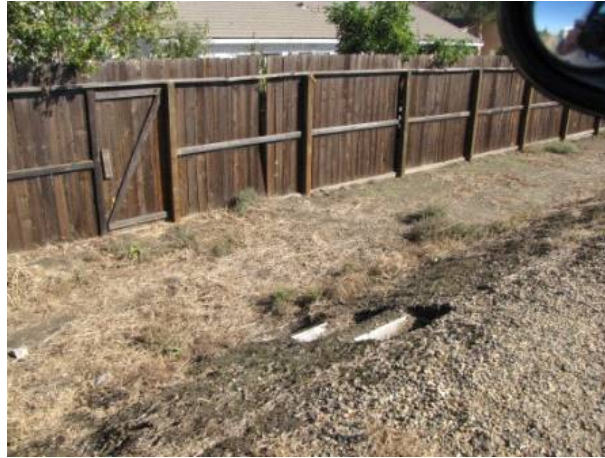
View of unauthorized steps dug into the landward slope looking upstream.

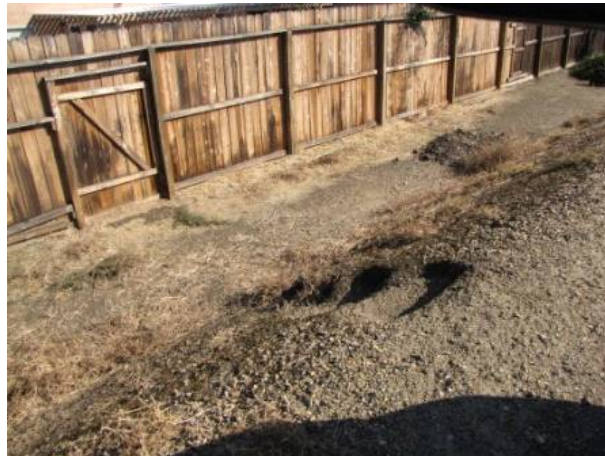
Levee Mile Report Line	13
Start Levee Mile	1.16
End Levee Mile	1.16
Location	Land Side
Category	Earthen Levee
Item	Encroachments

View of unauthorized steps dug into the landward slope looking upstream.

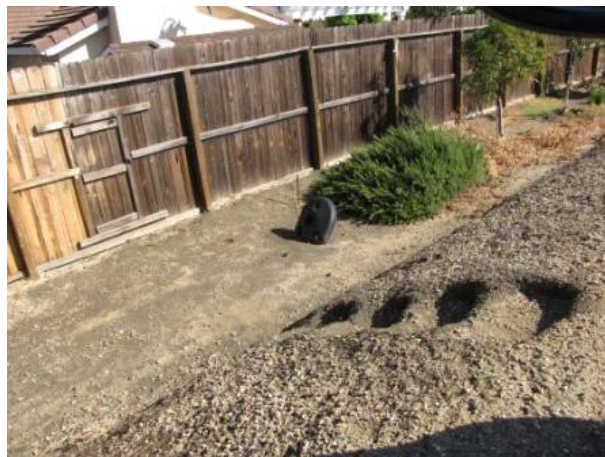
Levee Mile Report Line	14
Start Levee Mile	1.17
End Levee Mile	1.17
Location	Land Side
Category	Earthen Levee
Item	Encroachments

View of unauthorized steps dug into the landward slope looking upstream.

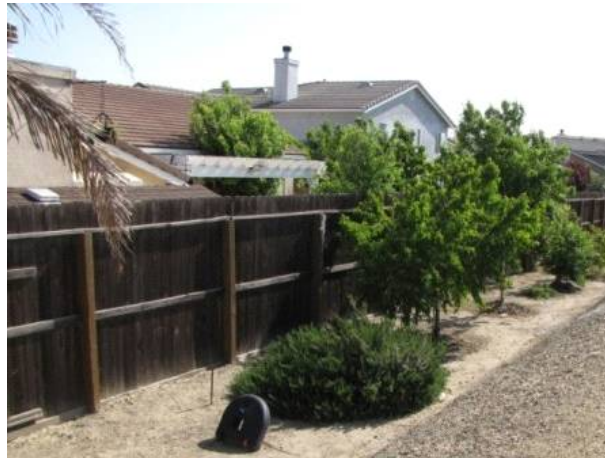
Landscaping within 10' of landward toe of levee.

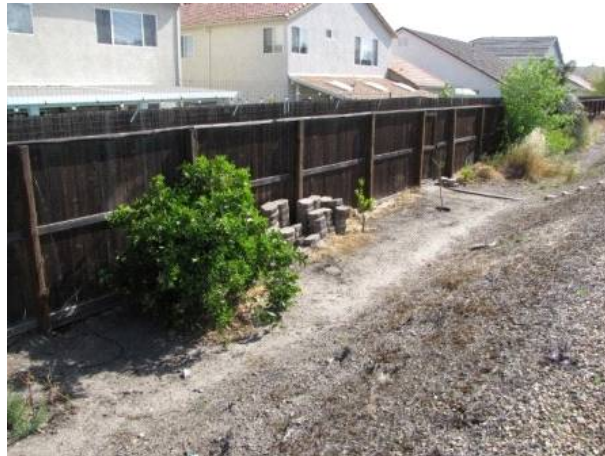
Levee Mile Report Line	16
Start Levee Mile	1.39
End Levee Mile	1.39
Location	Land Side
Category	Earthen Levee
Item	Encroachments

Landscaping within 10' of toe of levee.

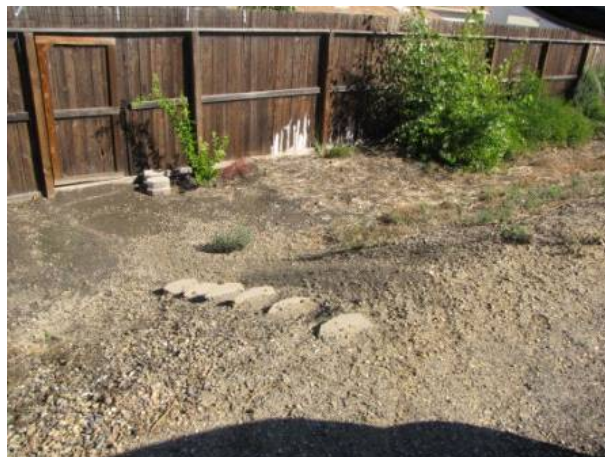
Levee Mile Report Line	17
Start Levee Mile	1.40
End Levee Mile	1.40
Location	Land Side
Category	Earthen Levee
Item	Encroachments

View of unauthorized steps dug into the landward slope looking upstream.

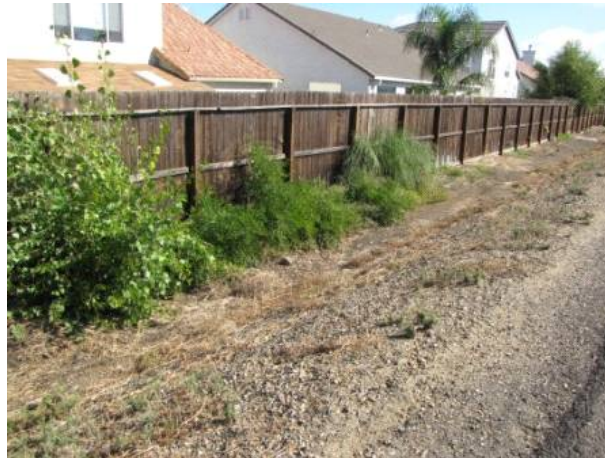
View of landscaping along the landward toe looking upstream.

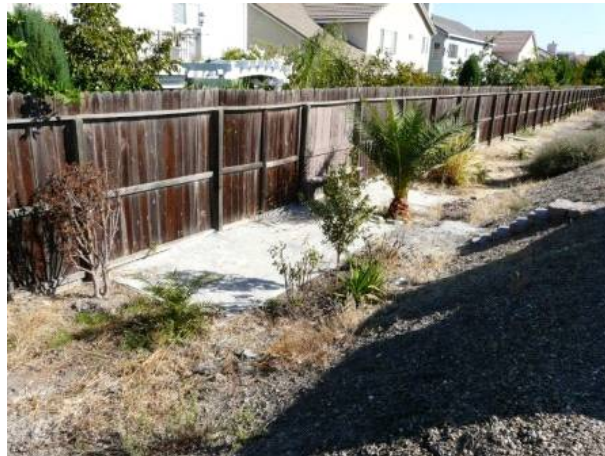
Levee Mile Report Line	19
Start Levee Mile	1.45
End Levee Mile	1.45
Location	Land Side
Category	Earthen Levee
Item	Encroachments

Landscaping located within 10' from landside toe of levee at LM 1.45.

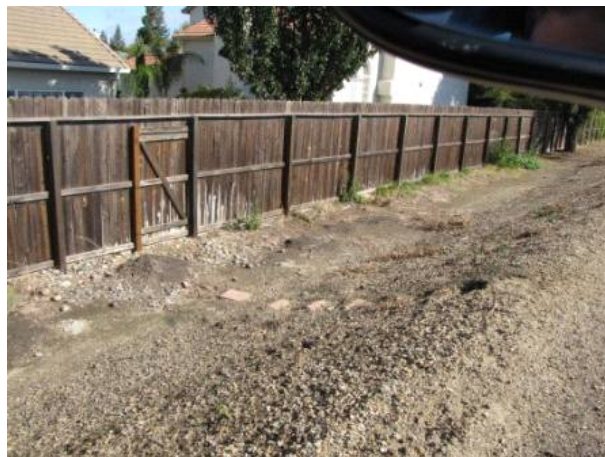
Levee Mile Report Line	20
Start Levee Mile	1.53
End Levee Mile	1.53
Location	Land Side
Category	Earthen Levee
Item	Encroachments

View of unauthorized steps dug into the landward slope looking upstream.

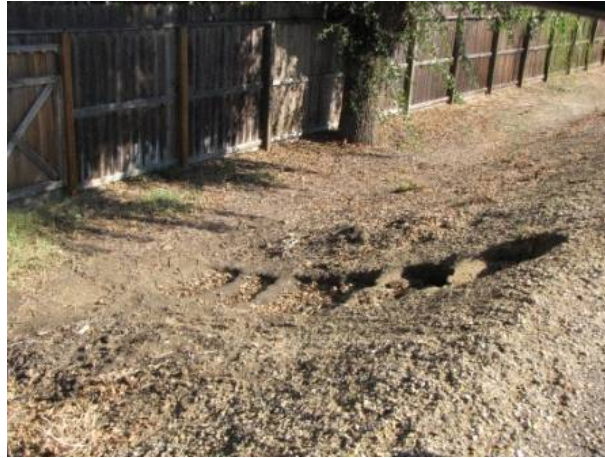
View of unauthorized steps dug into the landward slope looking upstream.

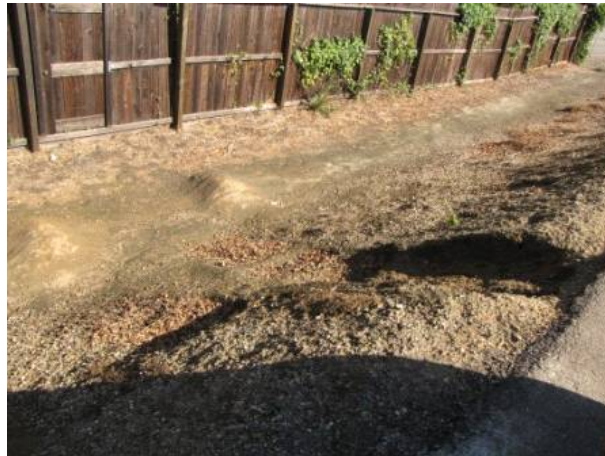
Levee Mile Report Line	22
Start Levee Mile	1.55
End Levee Mile	1.55
Location	Land Side
Category	Earthen Levee
Item	Slope Stability

View of unauthorized steps dug into the landward slope looking upstream.

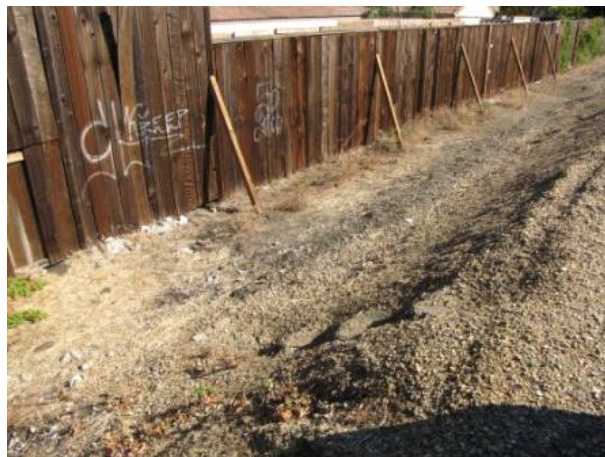
Levee Mile Report Line	23
Start Levee Mile	1.68
End Levee Mile	1.68
Location	Land Side
Category	Earthen Levee
Item	Encroachments

View of unauthorized steps dug into the landward slope looking upstream.

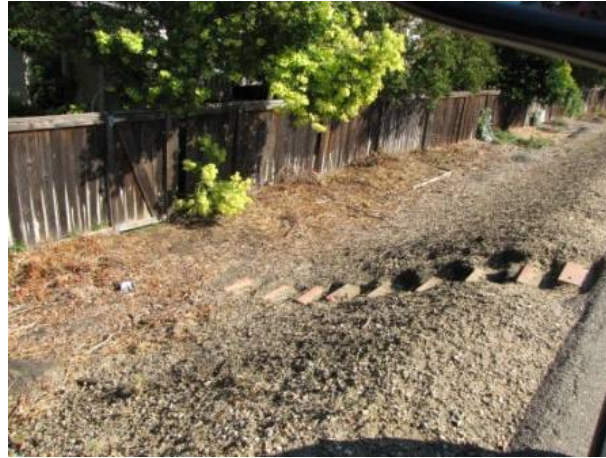
View of unauthorized steps dug into the landward slope looking upstream.

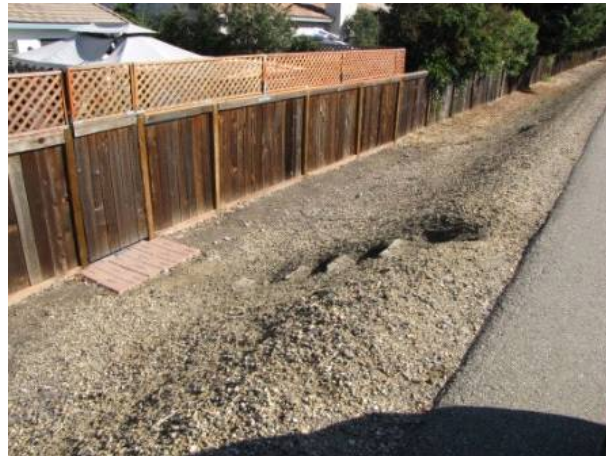
Levee Mile Report Line	25
Start Levee Mile	1.84
End Levee Mile	1.84
Location	Land Side
Category	Earthen Levee
Item	Encroachments

View of unauthorized steps dug into the landward slope looking upstream.

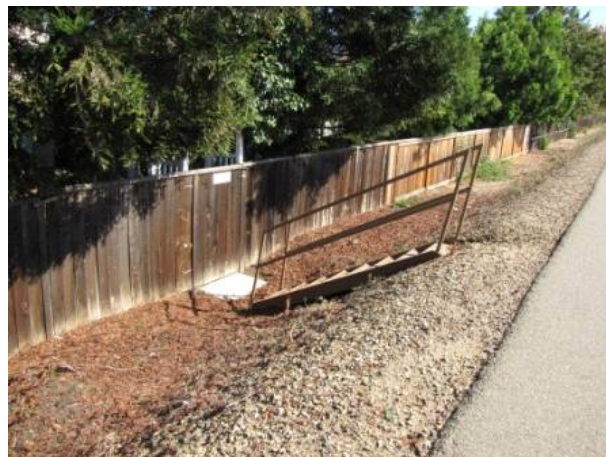
Levee Mile Report Line	26
Start Levee Mile	1.91
End Levee Mile	1.91
Location	Land Side
Category	Earthen Levee
Item	Encroachments

View of unauthorized steps dug into the landward slope looking upstream.

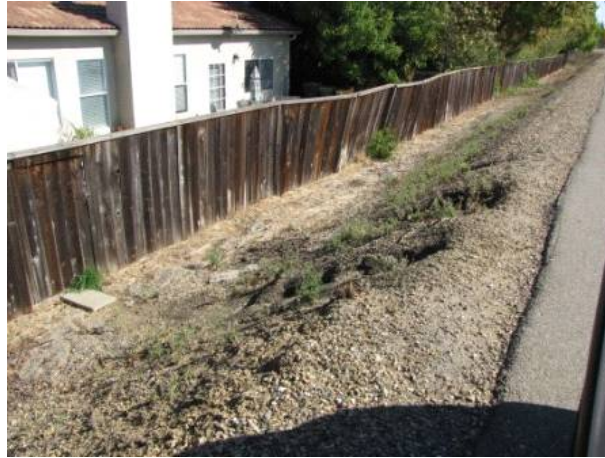
View of unauthorized steps dug into the landward slope looking upstream.

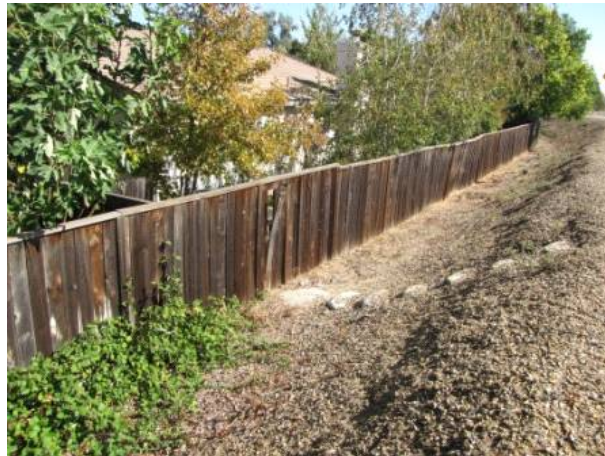
Levee Mile Report Line	28
Start Levee Mile	1.97
End Levee Mile	1.97
Location	Land Side
Category	Earthen Levee
Item	Encroachments

View of unauthorized steps dug into the landward slope looking upstream.

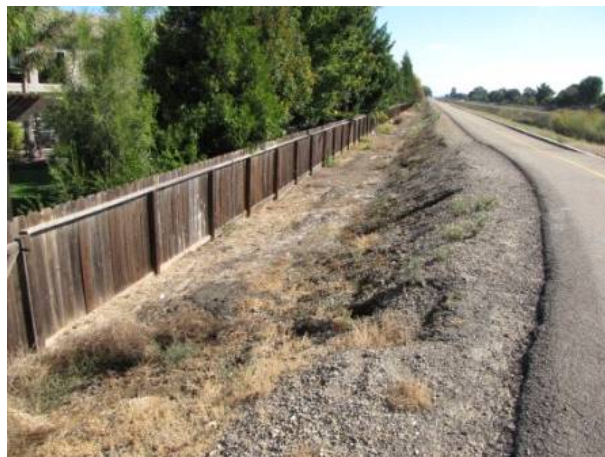
dpesaven_s_20100316_053.jpg

View of unauthorized steps dug into the landward slope looking upstream.

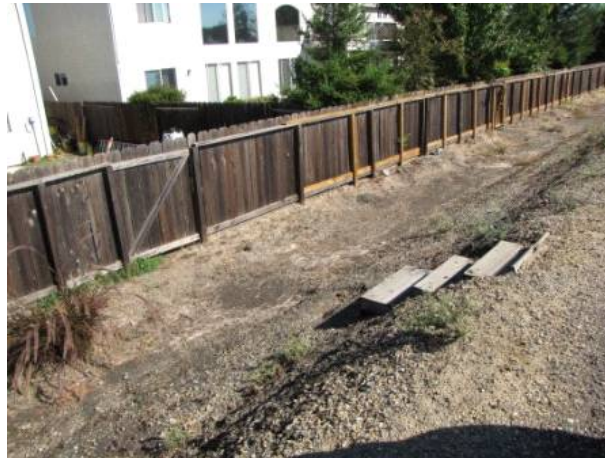
dpesaven_s_20100316_054.jpg

View of unauthorized steps dug into the landward slope looking upstream.

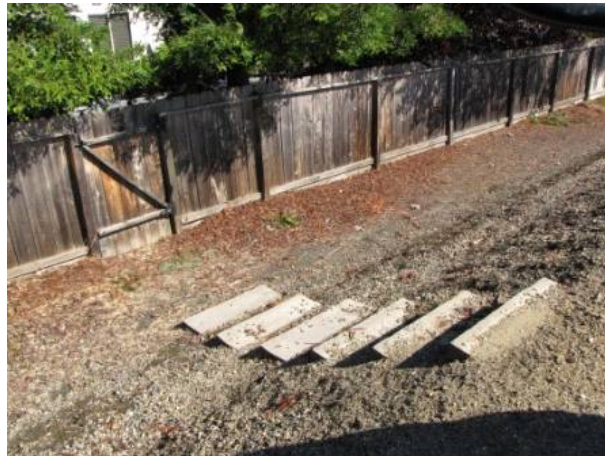
Levee Mile Report Line	31
Start Levee Mile	2.09
End Levee Mile	2.09
Location	Land Side
Category	Earthen Levee
Item	Encroachments

View of unauthorized steps dug into the landward slope looking upstream.

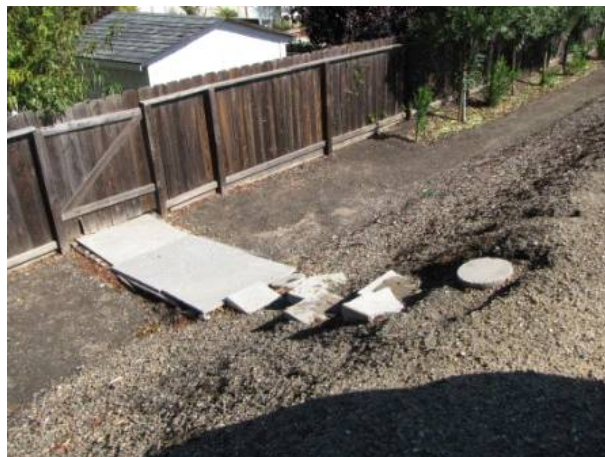
Levee Mile Report Line	32
Start Levee Mile	2.11
End Levee Mile	2.11
Location	Land Side
Category	Earthen Levee
Item	Encroachments

View of unauthorized steps dug into the landward slope looking upstream.

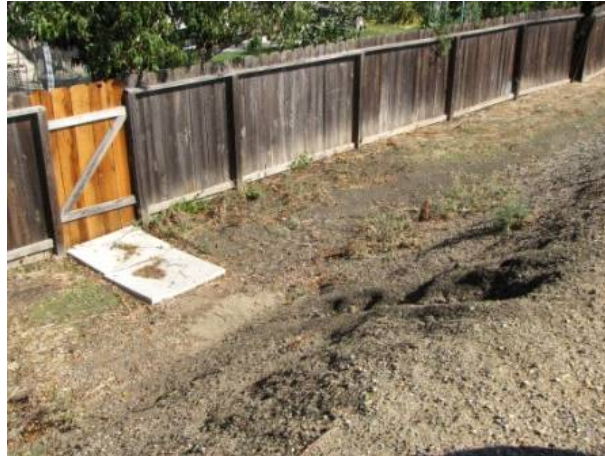
dpesaven_s_20100316_057.jpg

View of unauthorized steps dug into the landward slope looking upstream.

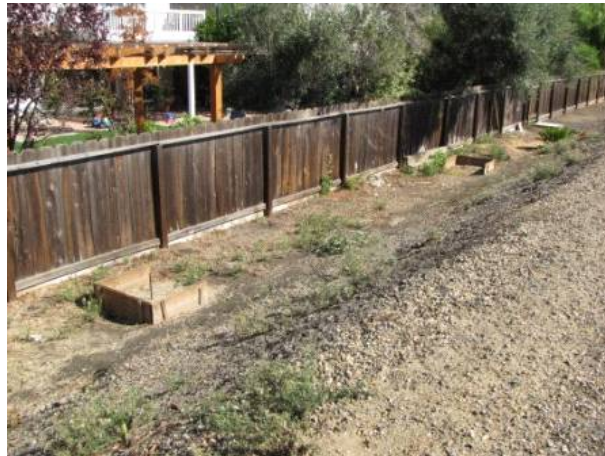
Levee Mile Report Line	34
Start Levee Mile	2.16
End Levee Mile	2.16
Location	Land Side
Category	Earthen Levee
Item	Encroachments

View of horseshoe pits along the landward toe looking upstream.

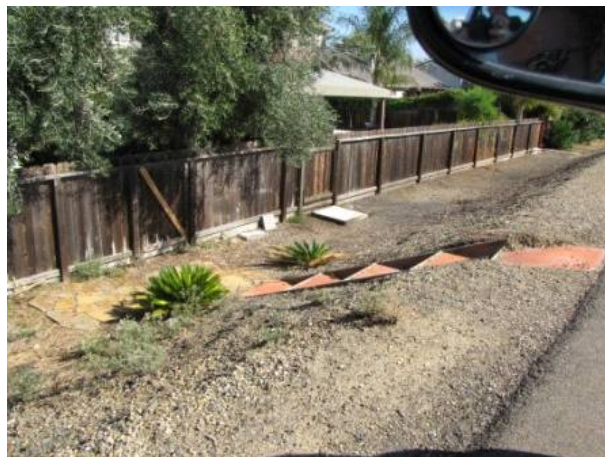
Levee Mile Report Line	35
Start Levee Mile	2.17
End Levee Mile	2.17
Location	Land Side
Category	Earthen Levee
Item	Encroachments

View of unauthorized steps dug into the landward slope looking upstream.

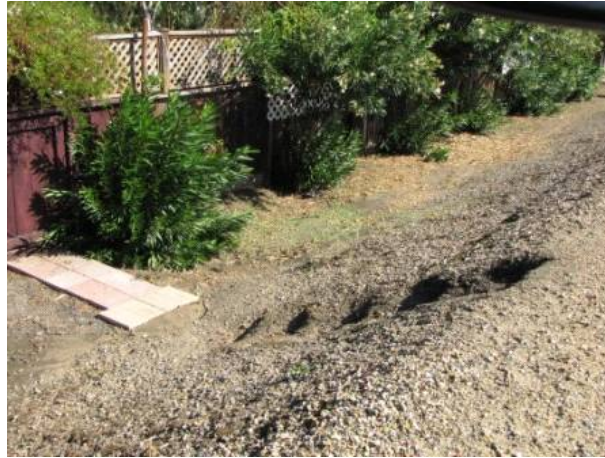
dpesaven_s_20100316_060.jpg

View of unauthorized steps dug into the landward slope looking upstream.

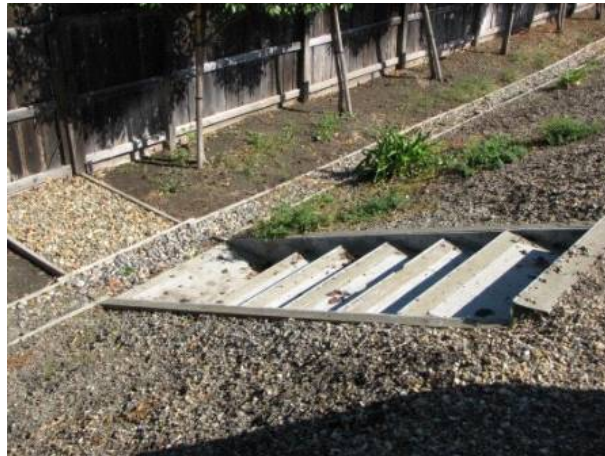
Levee Mile Report Line	37
Start Levee Mile	2.20
End Levee Mile	2.20
Location	Land Side
Category	Earthen Levee
Item	Encroachments

View of unauthorized steps dug into the landward slope looking upstream.

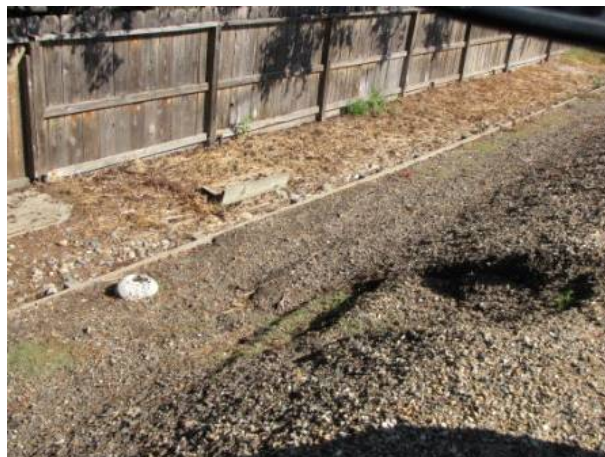
Levee Mile Report Line	38
Start Levee Mile	2.21
End Levee Mile	2.21
Location	Land Side
Category	Earthen Levee
Item	Encroachments

View of unauthorized steps dug into the landward slope looking upstream.

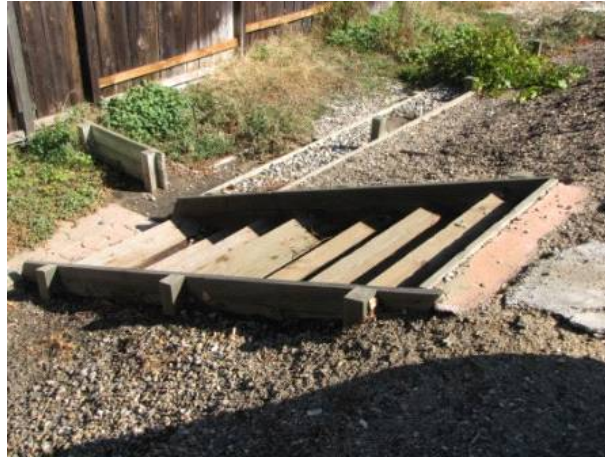
dpesaven_s_20100316_063.jpg

View of unauthorized steps dug into the landward slope looking upstream.

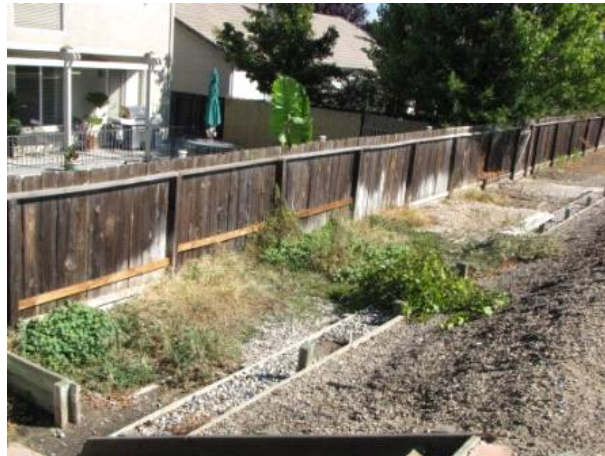
Levee Mile Report Line	40
Start Levee Mile	2.23
End Levee Mile	2.23
Location	Land Side
Category	Earthen Levee
Item	Encroachments

View of horseshoe pits and landscaping along the landward toe looking upstream.

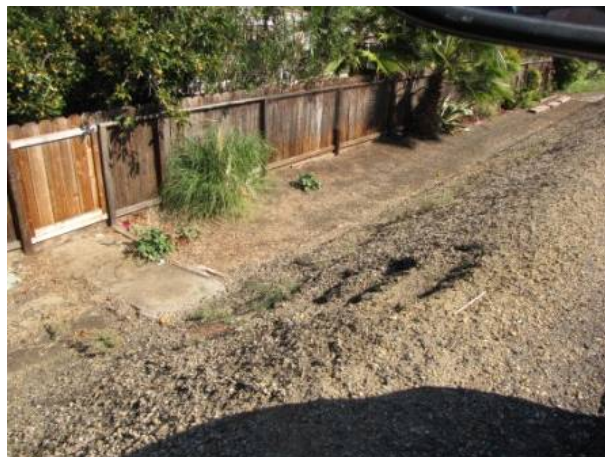
Levee Mile Report Line	41
Start Levee Mile	2.26
End Levee Mile	2.26
Location	Land Side
Category	Earthen Levee
Item	Encroachments

View of unauthorized steps dug into the landward slope looking upstream.

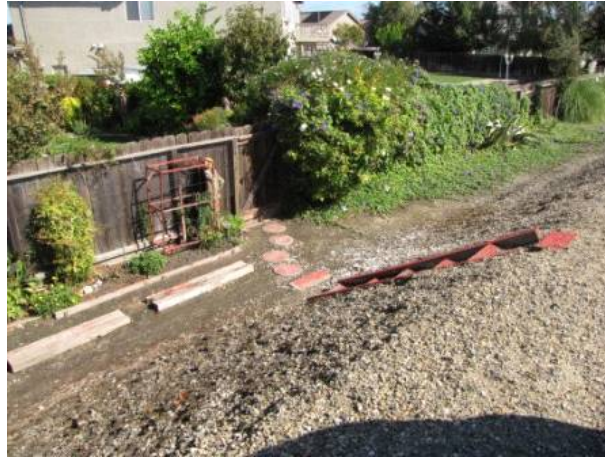
dpesaven_s_20100316_066.jpg

View of unauthorized steps dug into the landward slope and other landscaping looking upstream.

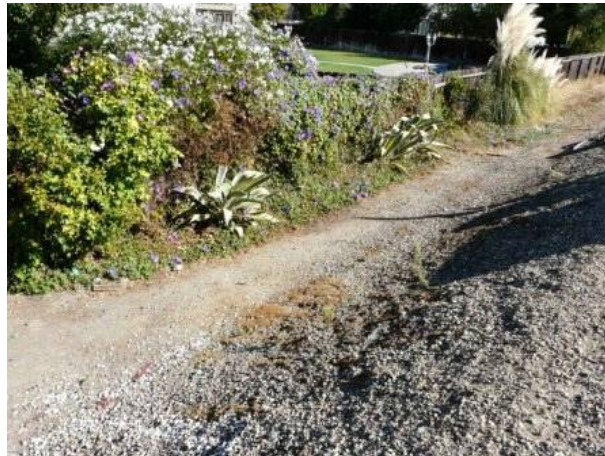
Levee Mile Report Line	43
Start Levee Mile	2.28
End Levee Mile	2.28
Location	Land Side
Category	Earthen Levee
Item	Encroachments

Landscaping located within 10' of landside toe of levee at LM 2.28.

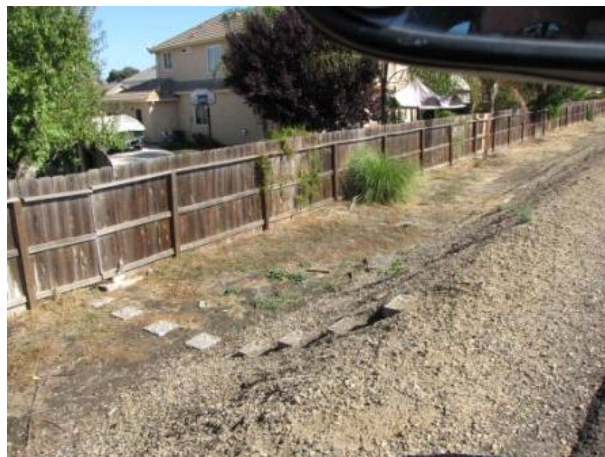
Levee Mile Report Line	44
Start Levee Mile	2.33
End Levee Mile	2.33
Location	Land Side
Category	Earthen Levee
Item	Encroachments

View of unauthorized steps dug into the landward slope looking upstream.

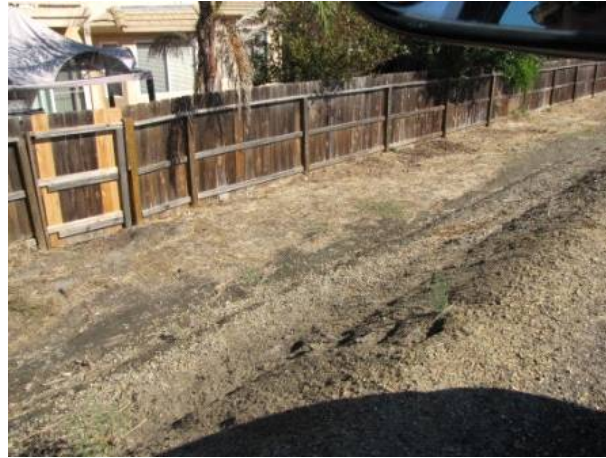
dpesaven_s_20100316_068.jpg

View of unauthorized steps dug into the landward slope looking upstream.

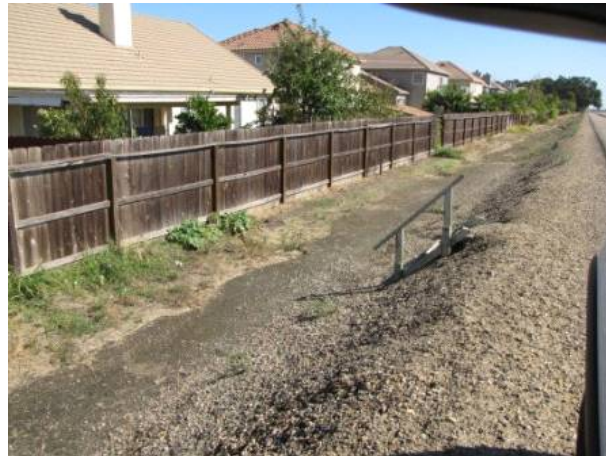
Levee Mile Report Line	46
Start Levee Mile	2.38
End Levee Mile	2.38
Location	Land Side
Category	Earthen Levee
Item	Encroachments

View of unauthorized steps dug into the landward slope looking upstream.

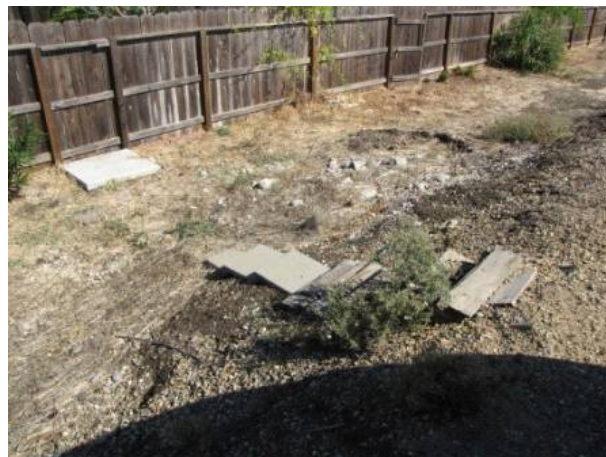
Levee Mile Report Line	47
Start Levee Mile	2.41
End Levee Mile	2.41
Location	Land Side
Category	Earthen Levee
Item	Encroachments

View of unauthorized steps dug into the landward slope looking upstream.

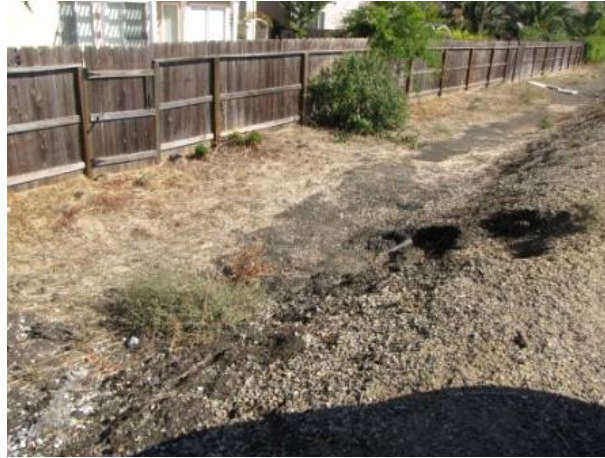
dpesaven_s_20100316_071.jpg

View of unauthorized steps dug into the landward slope looking upstream.

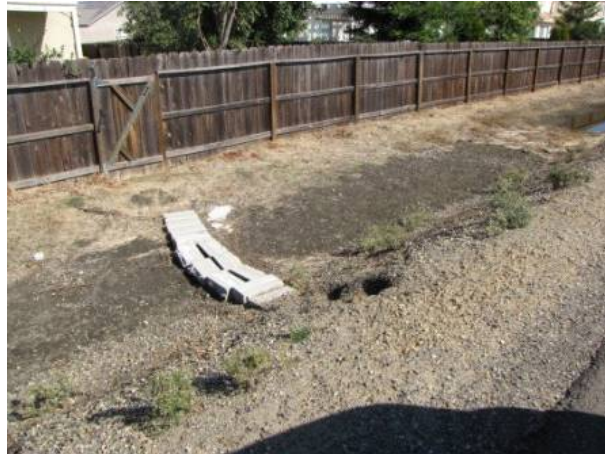
Levee Mile Report Line	49
Start Levee Mile	2.46
End Levee Mile	2.46
Location	Land Side
Category	Earthen Levee
Item	Encroachments

View of unauthorized steps dug into the landward slope looking upstream.

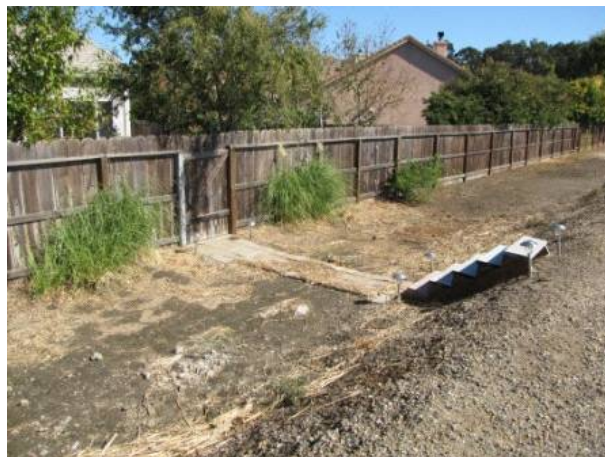
Levee Mile Report Line	50
Start Levee Mile	2.49
End Levee Mile	2.49
Location	Land Side
Category	Earthen Levee
Item	Encroachments

View of unauthorized steps dug into the landward slope looking upstream.

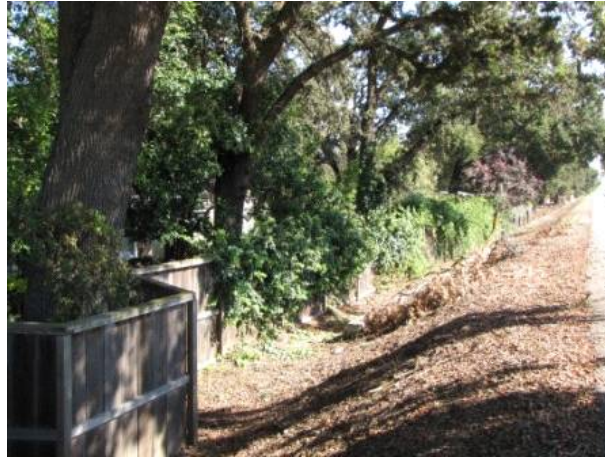
dpesaven_s_20100316_074.jpg

View of a wood fence adjacent to the landward toe looking upstream.

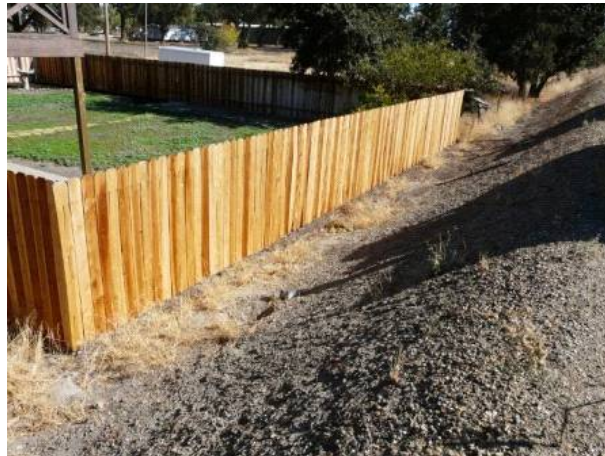
Levee Mile Report Line	52
Start Levee Mile	2.66
End Levee Mile	2.67
Location	Land Side
Category	Earthen Levee
Item	Encroachments

Newer fence built within landside toe of levee at from LM 2.66 to LM 2.67.

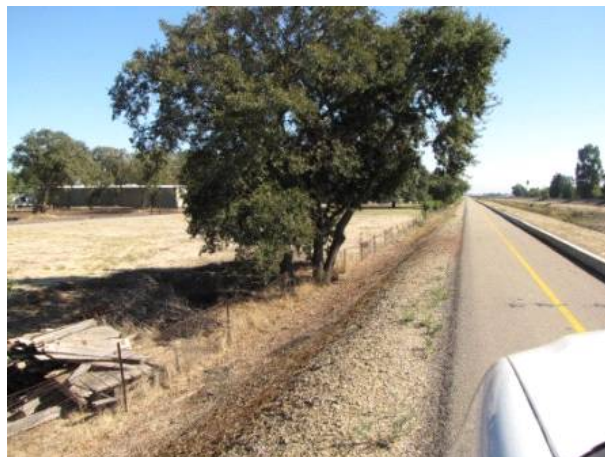
Levee Mile Report Line	53
Start Levee Mile	2.68
End Levee Mile	3.04
Location	Land Side
Category	Earthen Levee
Item	Encroachments

View of a metal fence adjacent to the landward toe looking upstream.

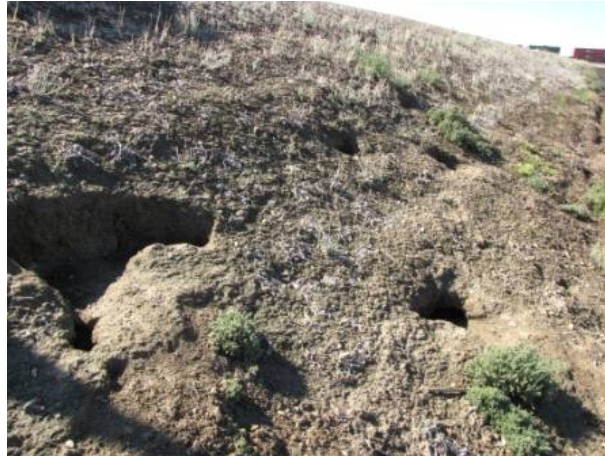
dpesaven_s_20100316_076.jpg

View of rodent holes in the landward slope.

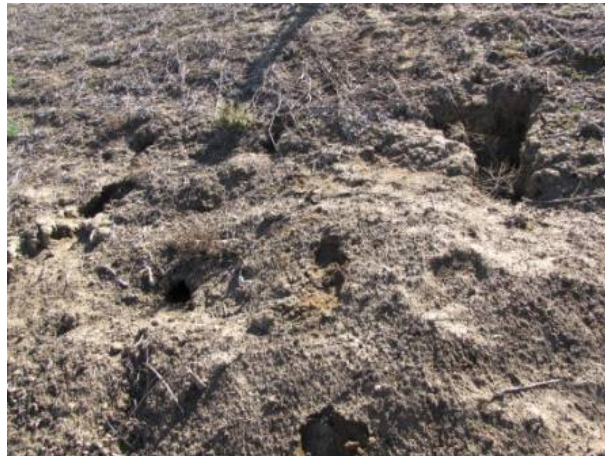
Levee Mile Report Line	61
Start Levee Mile	3.92
End Levee Mile	3.92
Location	Land Side
Category	Earthen Levee
Item	Animal Control

View of rodent holes in the landward slope.

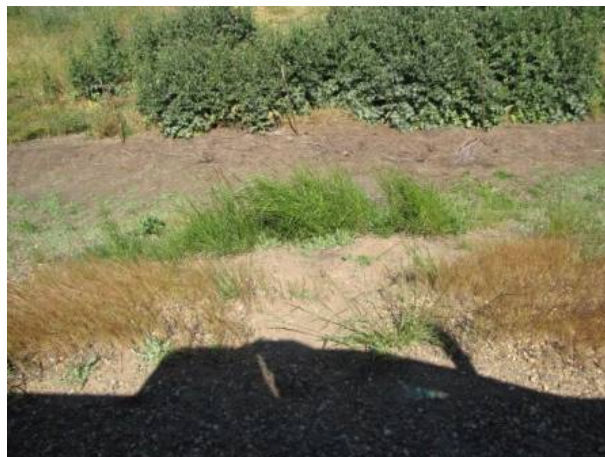
Levee Mile Report Line	67
Start Levee Mile	4.80
End Levee Mile	4.80
Location	Land Side
Category	Earthen Levee
Item	Erosion / Bank Caving

View of depression in the landward slope.

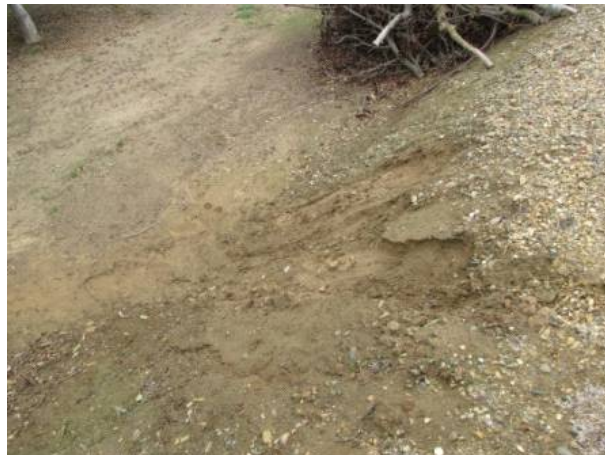
dpesaven_s_20100316_087.jpg

View of erosion occurring on the landward slope.

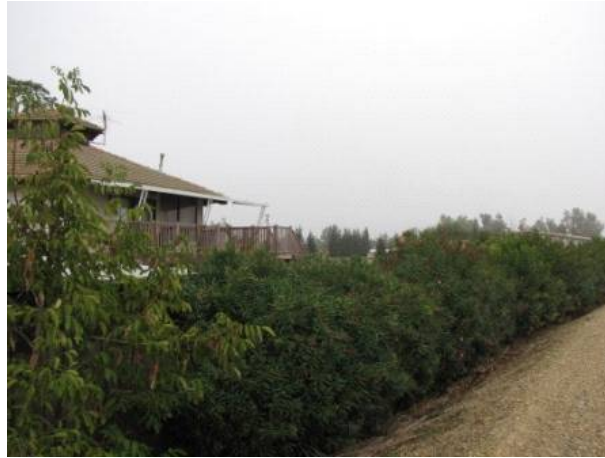
dpesaven_s_20100316_088.jpg

View of landscaping along the landward slope and toe looking upstream.

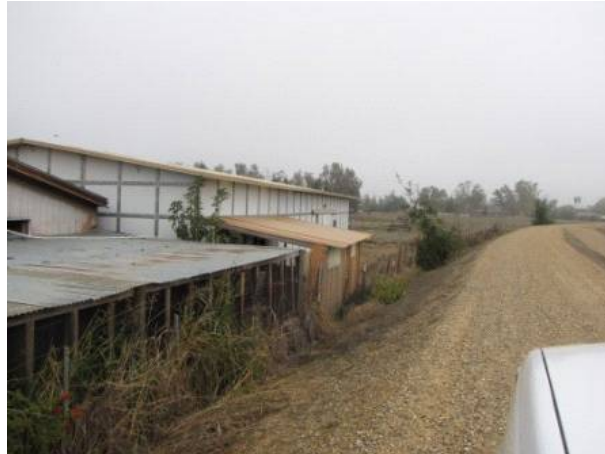
Levee Mile Report Line	91
Start Levee Mile	10.39
End Levee Mile	10.62
Location	Land Side
Category	Earthen Levee
Item	Encroachments

View of a metal fence and structure adjacent to the landward toe looking upstream.

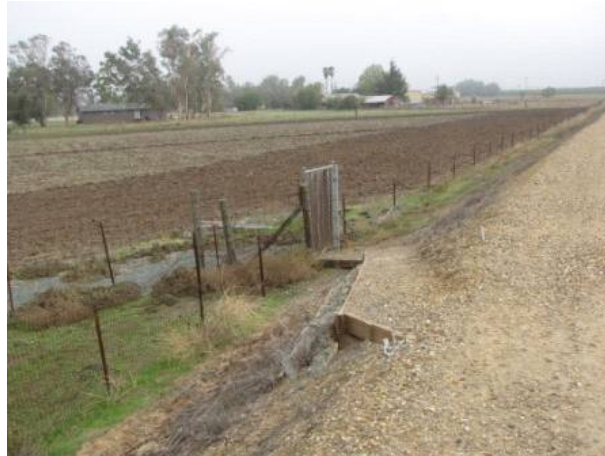
dpesaven_s_20100316_090.jpg

View of a ramp built into the landward slope looking upstream.

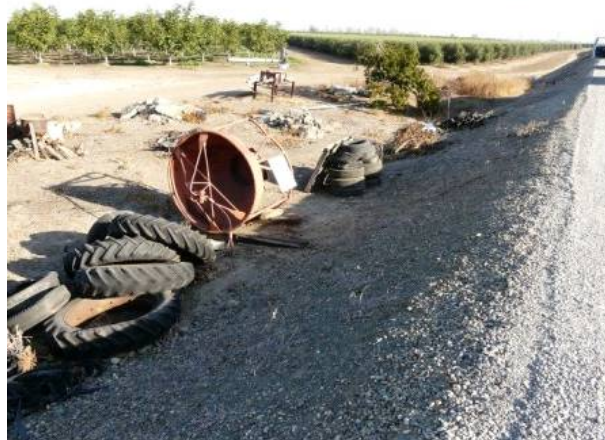
Levee Mile Report Line	95
Start Levee Mile	10.95
End Levee Mile	10.96
Location	Land Side
Category	Earthen Levee
Item	Encroachments

Debris located along landside toe of levee from LM 10.95 to LM 10.96.
